Manhole Inspection Summary

Manhole # S25GG_035MH

Insp Date: **9/10/07 9:53 AM**

Location Address: **584 PRESSTMAN ST**

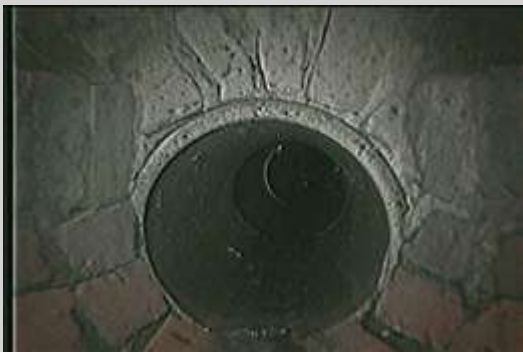
8 in. Circular Gravity Sewer Pipe Out @ 12 O'Clock

Pipe Material: **Clay** ☐ Pipe Lined

Invert Depth: **10.60** (ft.) Flow Characteristics: **Slow**

Deposits: ☒ None ☐ Mud ☐ Sludge ☐ Debris ☐ Grease

Infiltration: **None** Pipe Seal Cond: **Unknown**

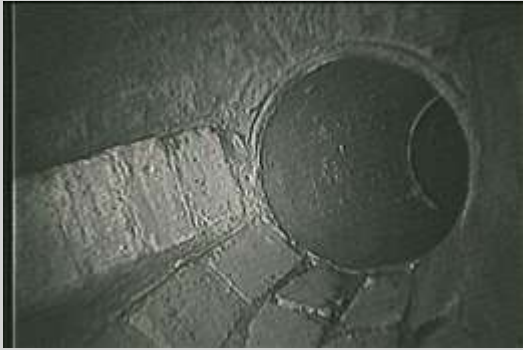
8 in. Circular Gravity Sewer

Pipe Material: **Clay** ☐ Pipe Lined

Infiltration: **None** Pipe Seal Cond: **Unknown**
